# Situation Photo Log

Friday, June 1, 2012

Kalamazoo River / Enbridge Spill

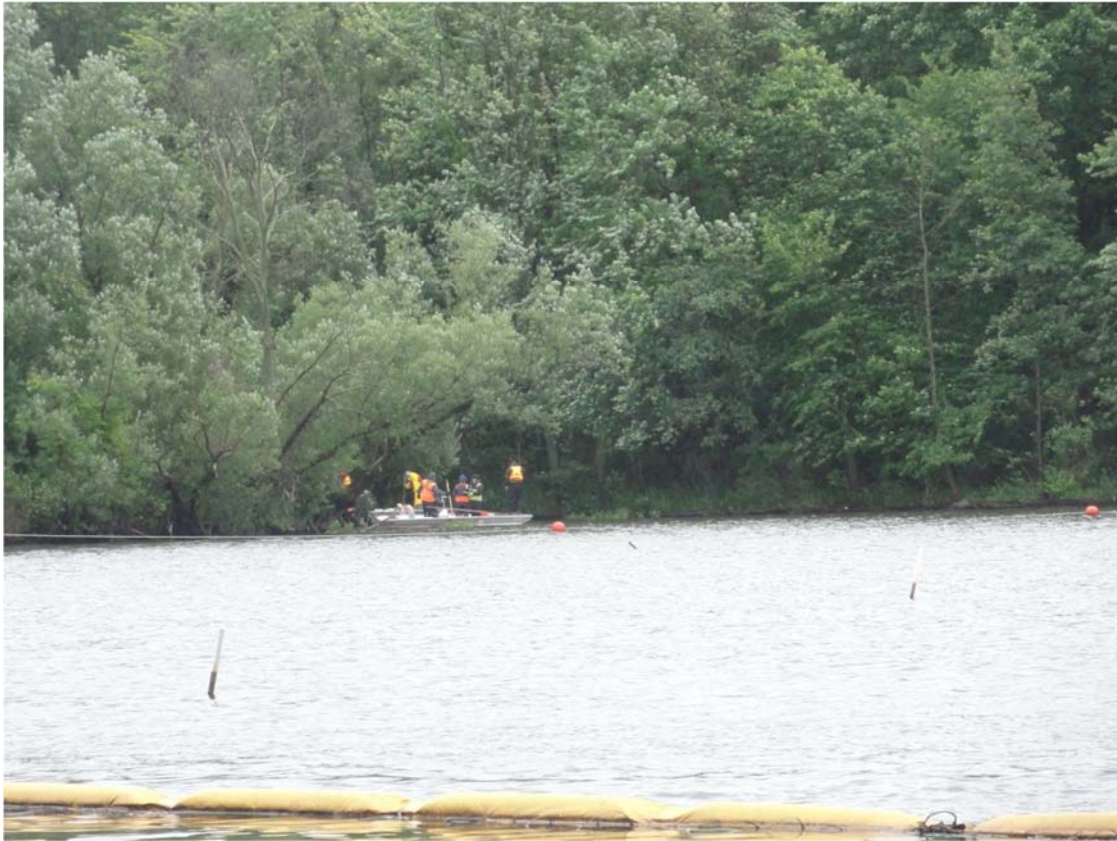
**25. MP37.75 poling crew observed.**

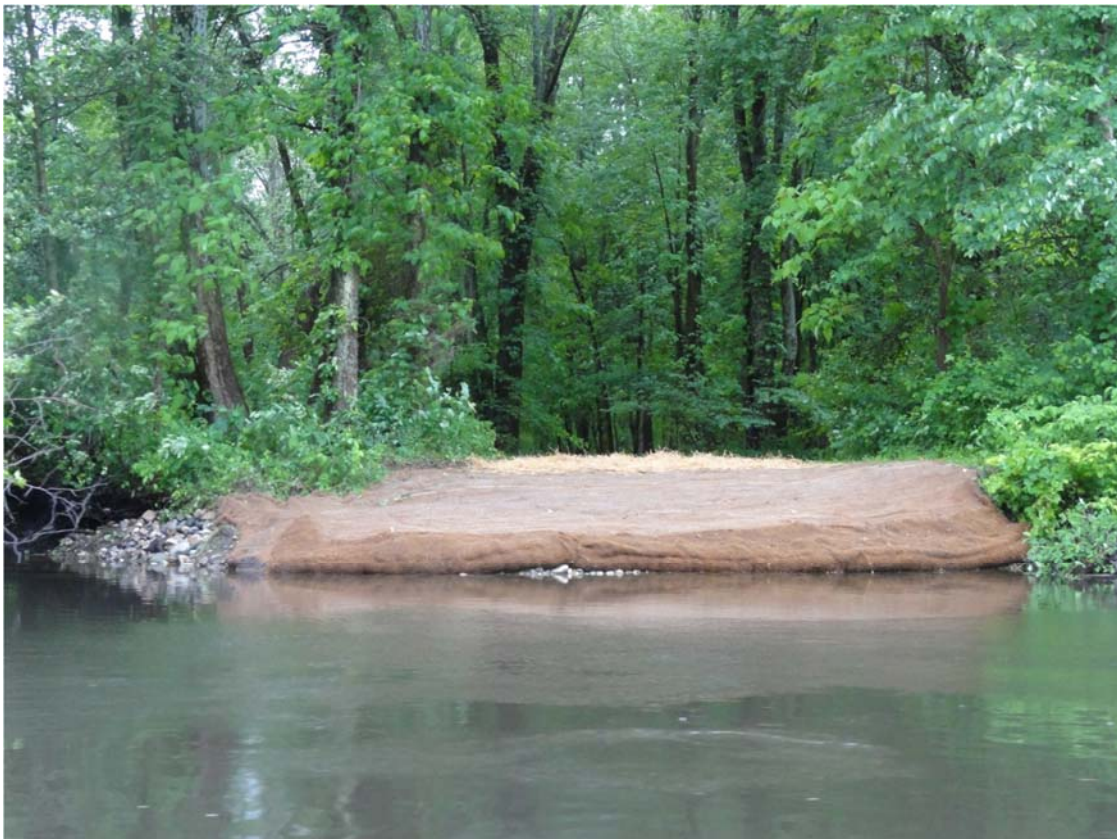
**26. MP32.5 LDB shore line erosion restoration observed.**

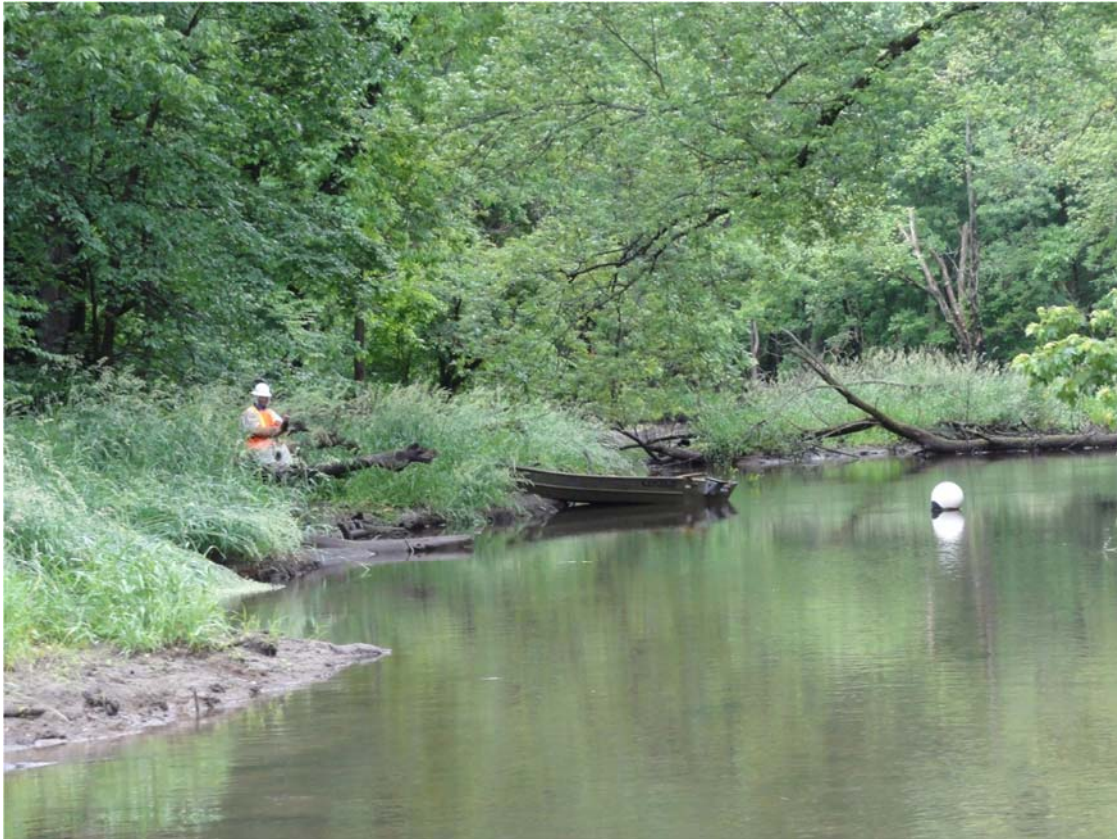
27. MP28.25 cylindrical sampling device sampling observed.

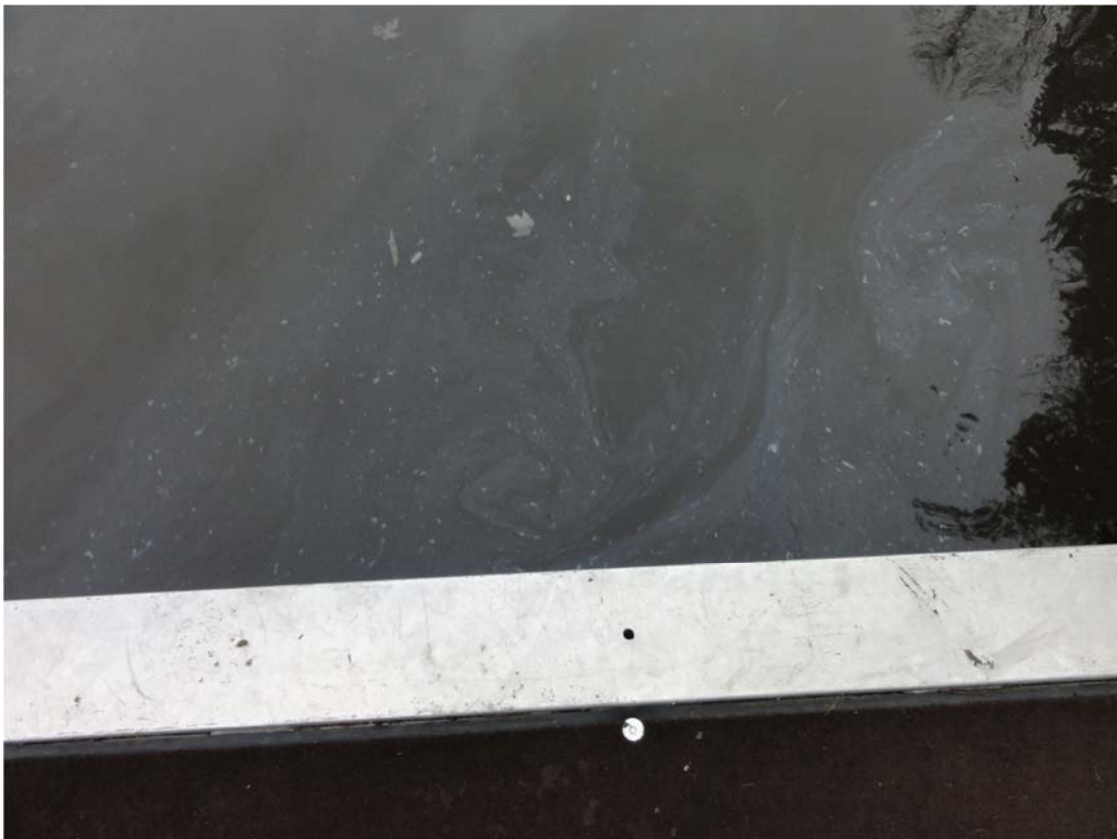
28. MP28.0 LDB sheen observed.

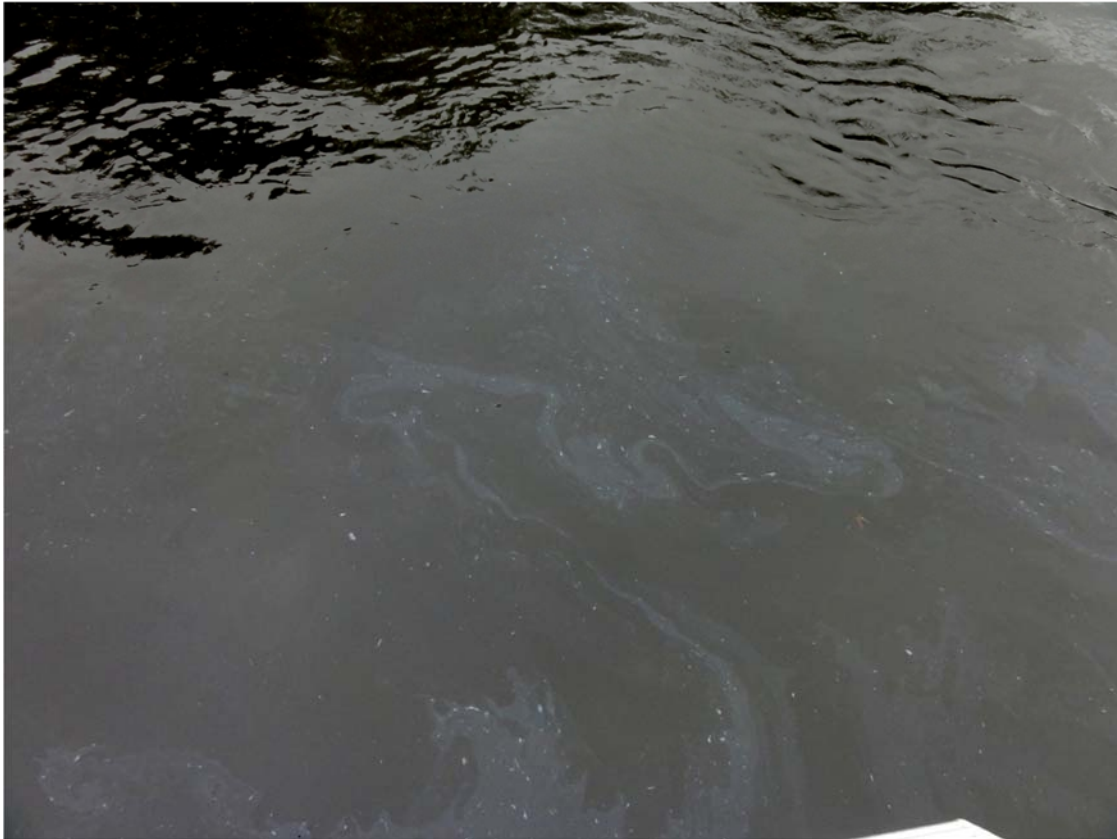
29. MP28.0 LDB sheen observed.

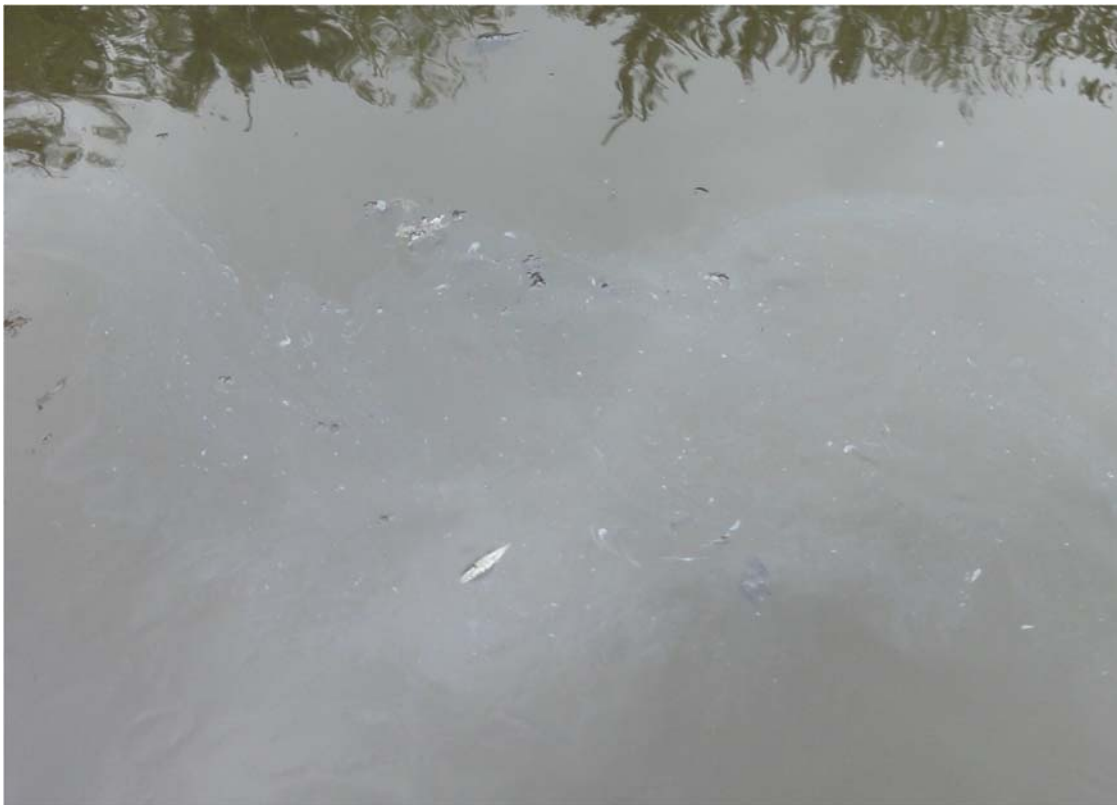
30. MP28.0 LDB sheen observed.

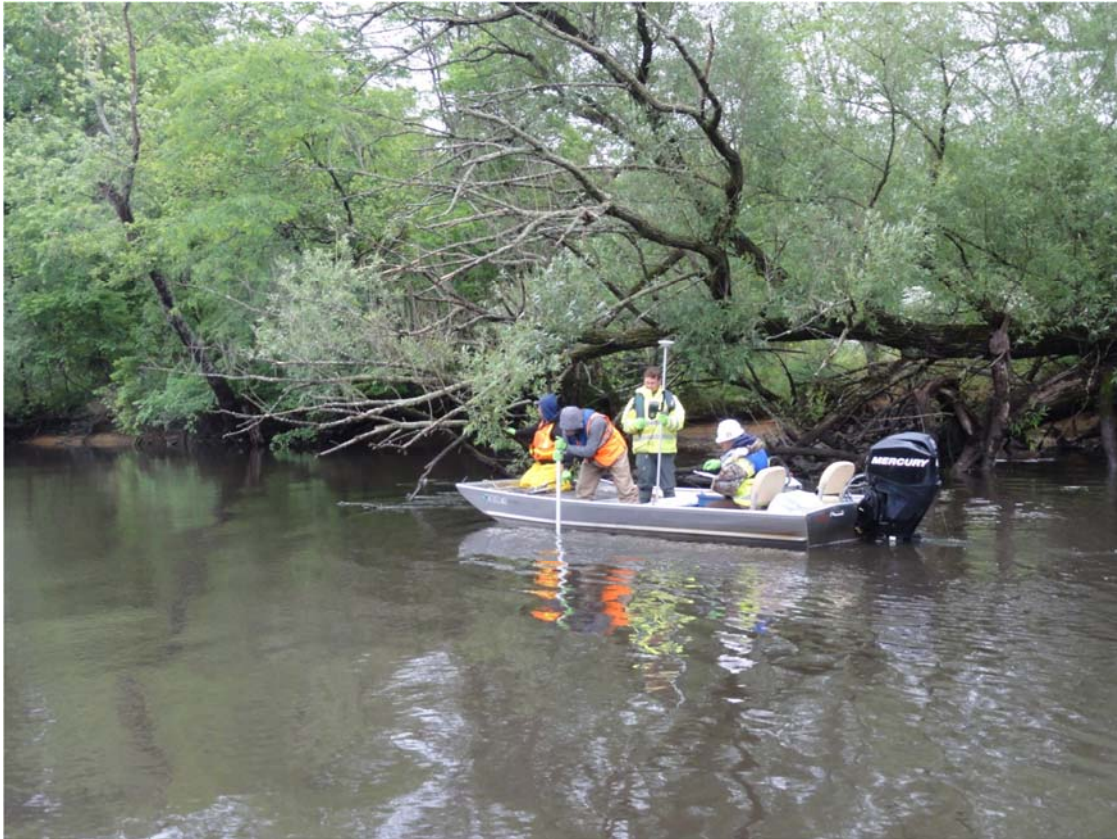
31. MP27.75 poling crew observed.

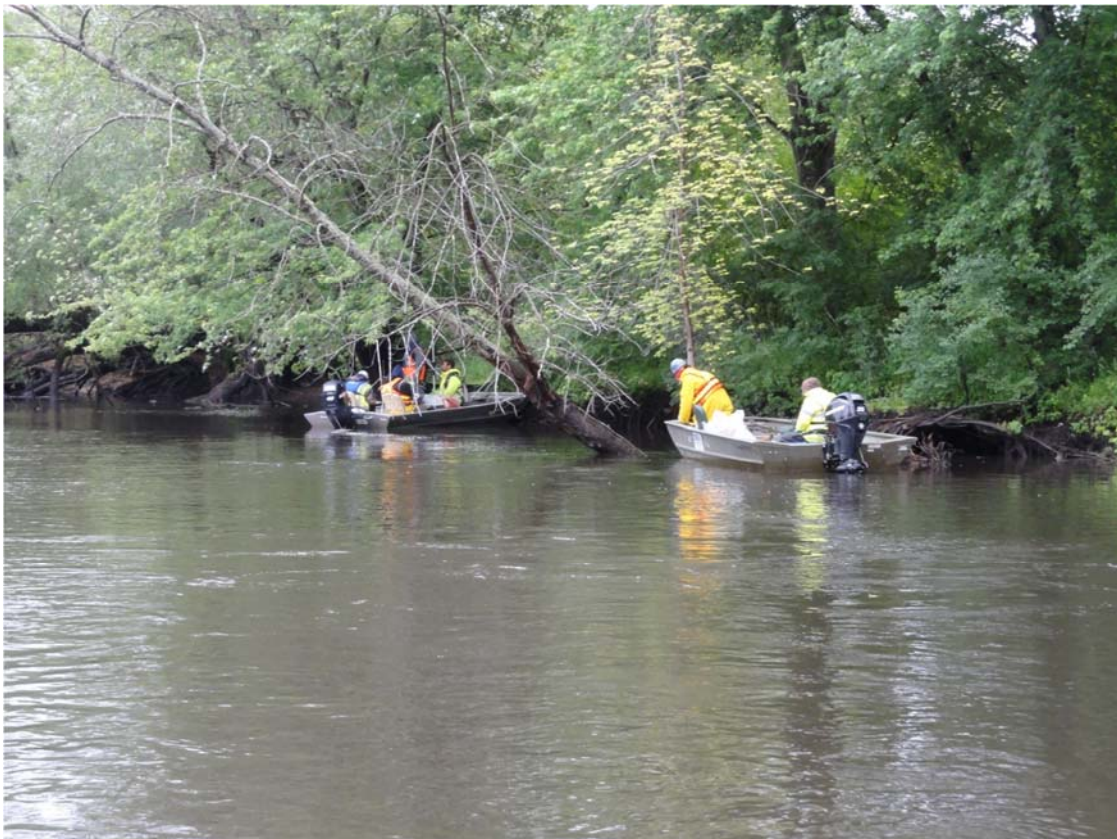
32. MP27.75 poling crew observed.

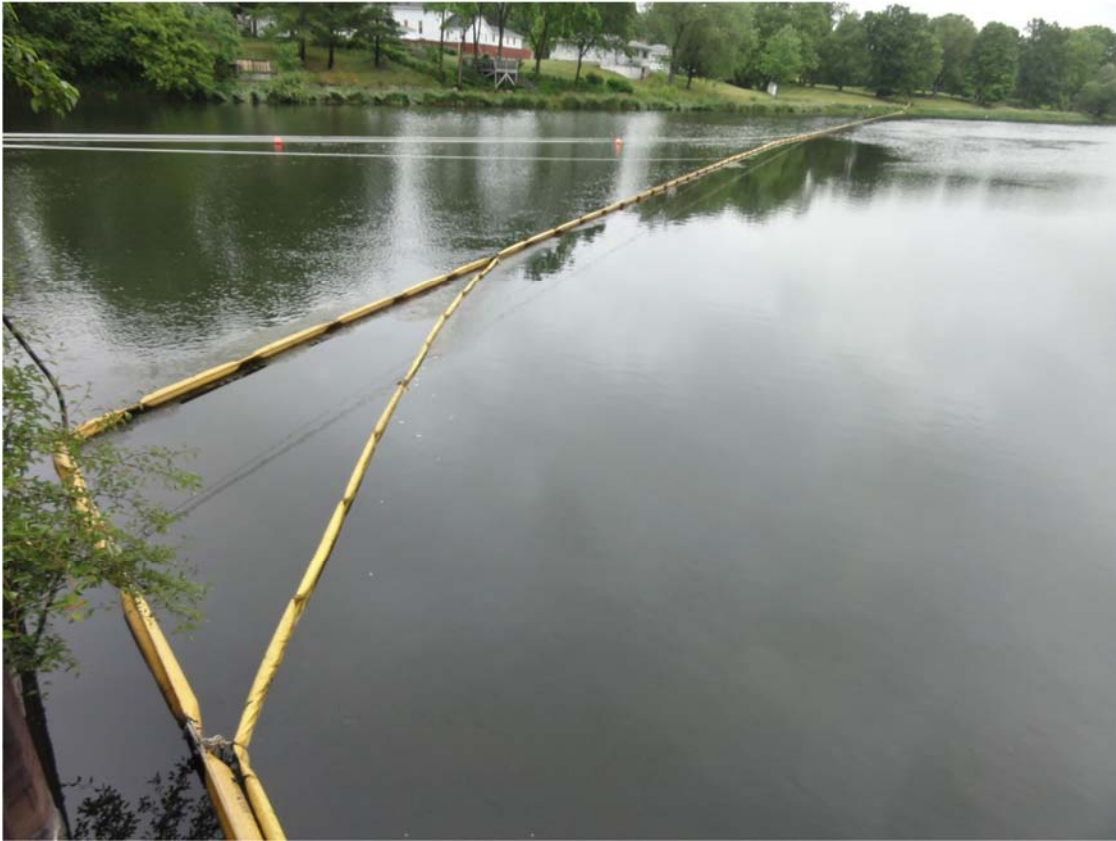
**33. Ceresco Dam boom.**

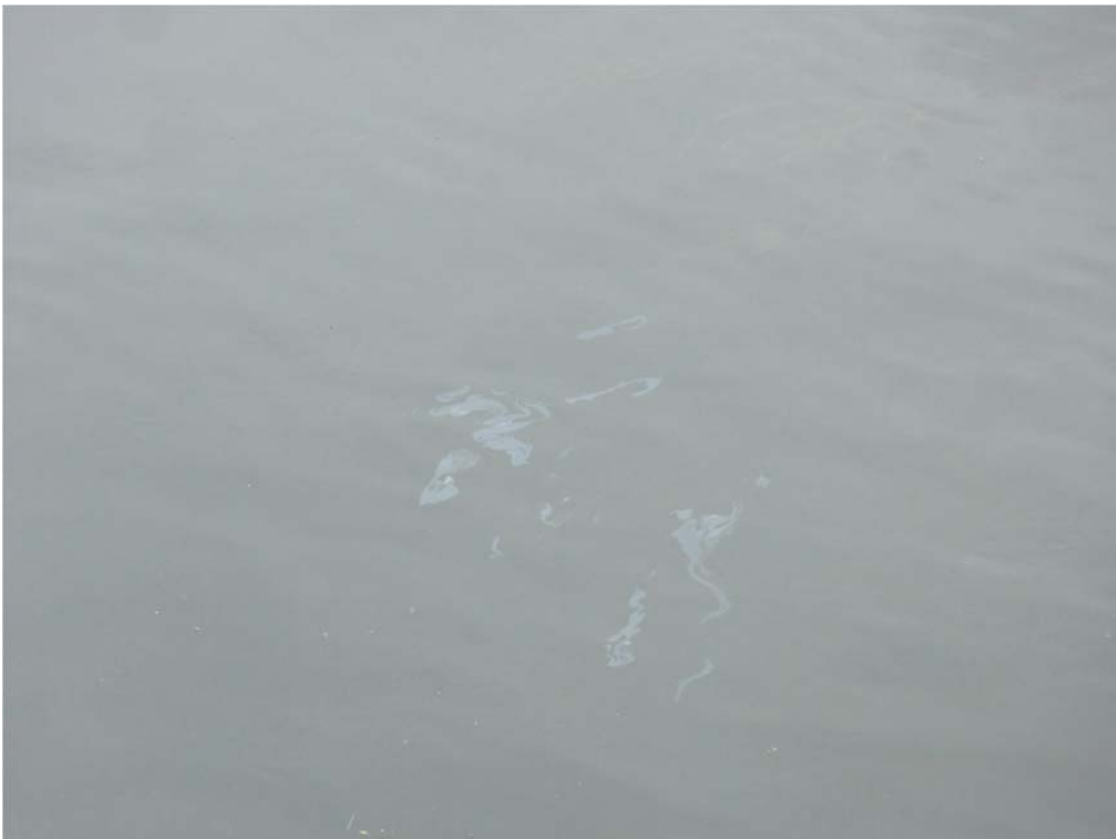
**34. Ceresco Dam sheen observed.**
